Case No. 4:15-cv-00250-TUC-DCB

**DECLARATION OF ELDON VAIL
IN SUPPORT OF PLAINTIFFS'
MOTION FOR PRELIMINARY
INJUNCTION**

2 6. I have been asked by Plaintiffs’ counsel to offer my opinions regarding the
3 conditions of confinement in Tucson Sector Border Patrol Station Hold Rooms (“Hold
4 Rooms”).

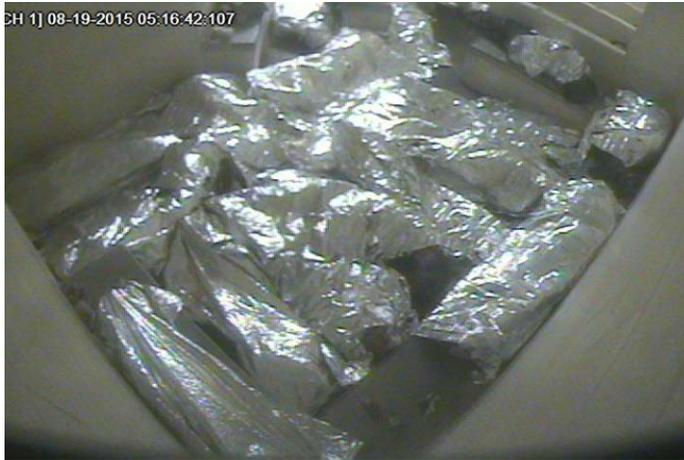
9 (Ex. 188).

16 32. Surveillance video from Tucson Station reveals that Defendants routinely
17 pack so many individuals into holding cells that detainees are commonly forced to lie
18 down on the concrete floors beneath the toilet stalls. Others are crammed so tightly, they
19 look like sardines in a can, with no room to move in any direction without rolling over
20 someone else:

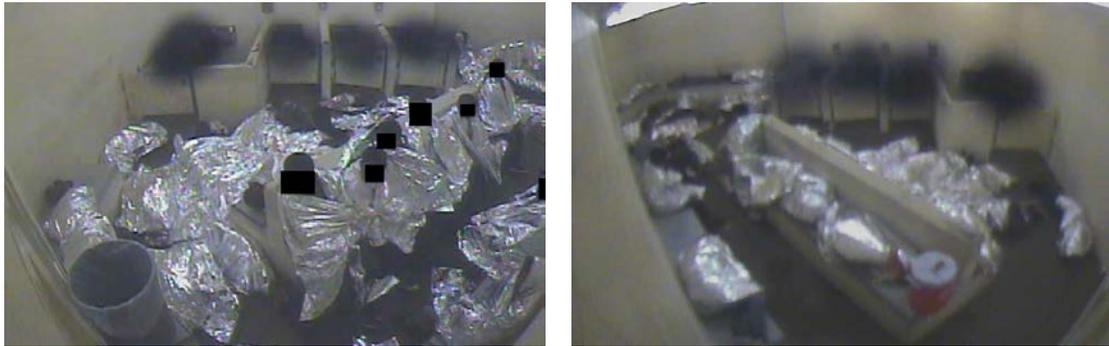
3 52. Although CBP apparently has no policies with respect to how often the Hold
 4 Rooms must be cleaned, surveillance footage from Casa Grande station shows hold rooms
 5 being cleaned once per 48 hours, if that. (Coles Decl. ¶ 41.) There are no cleaning
 6 supplies in the hold rooms and, according to detainees, the rooms often lacked a trash can.
 7 (ECF No. 2-1, Ex. 8 ¶ 11; *id.*, Ex. 16 ¶ 25; *id.*, Ex. 43 ¶ 15.) This means, effectively, that
 8 the Hold Rooms are hardly ever clean and that the areas around the toilets are generally
 9 dirty. (ECF No. 2-1, Ex. 8 ¶ 11 (diapers, toilet paper and other trash was strewn around
 10 the bathroom area); ECF No. 2-3, Ex. 35 ¶ 24 (1 toilet backed up and smelled terrible).)
 11 Unfortunately, this fact does not stop the overcrowding of the cells which makes it
 12 necessary for some detainees to lie down very close to those toilets in order to find a place

13 to sleep:

20
 21 (Ex. 173, 174; Ex. 152; *see also* ECF No. 2-2, Ex. 32 ¶ 10 (people were so tightly packed
 22 into the cell some had to sleep in the bathroom area); *id.*, Ex. 17 ¶ 7 (same); ECF No. 2-1,
 23 Ex. 7 ¶ 13 (one detainee sat upright on the concrete floor for two nights, finding it
 24 impossible to sleep more than a couple of hours during the time he was detained); *id.*,
 25 Ex. 11 ¶ 12 (several detainees explained that in order to find space to sleep on the floor,
 26 some detainees resorted to sleeping next to toilets.)) In essence, the design of the Hold
 27 Rooms mean that the person using the toilet and the person trying to sleep both experience
 28

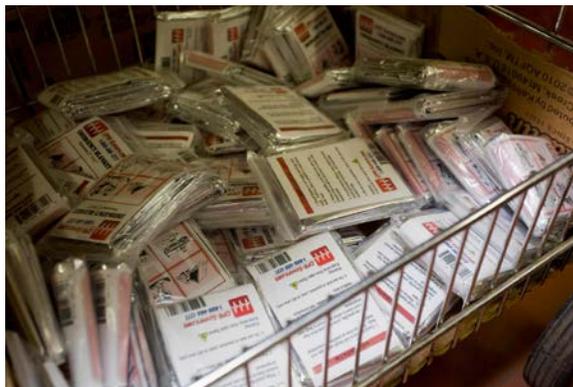
21 (Ex. 4.)

11 55. The only coverings I found were thin sheets made of Mylar, a material
12 similar in appearance to, but more durable than, aluminum. These sheets are almost paper
13 thin, but are referred to by CBP agents as “Mylar blankets”:

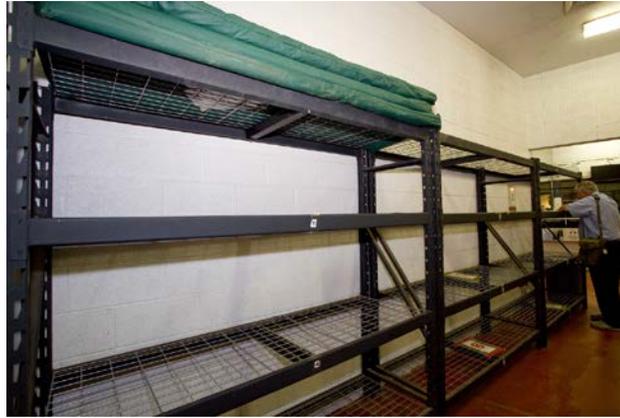
(Ex. 3.)

25 57. During my inspection of Casa Grande station, there were only three mats in
26 the entire facility:

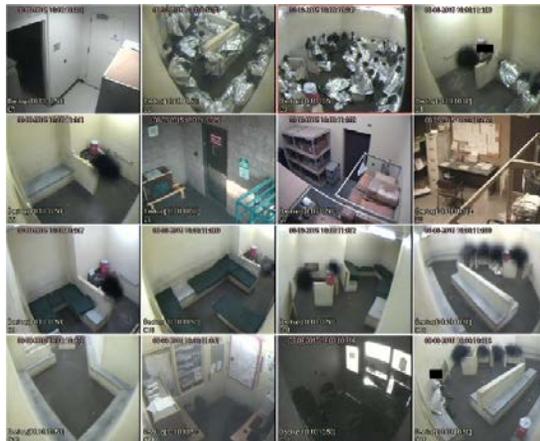
(Ex. 170; *see also* Ex. 147.)

59. Surveillance video from some of these stations often shows detainees lying on the concrete floors while, at the exact same moment in time in the same station, mats go unused in other unoccupied or less occupied cells:

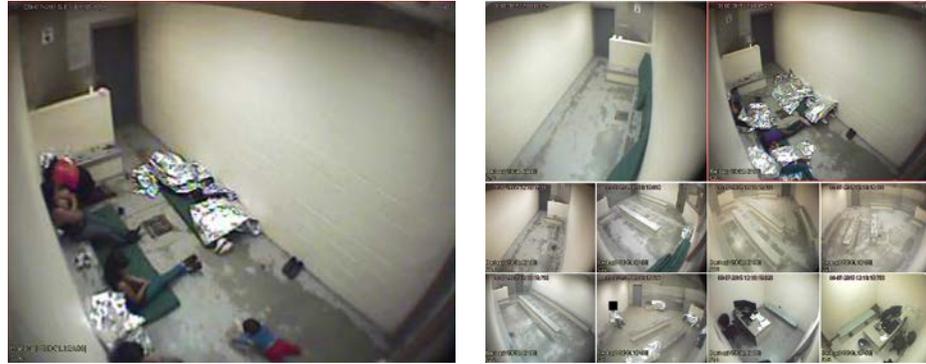
(Ex. 146, 147; *see also* Ex. 155.)

60. Surveillance video also shows families and children confined in cells with too few or no mats:

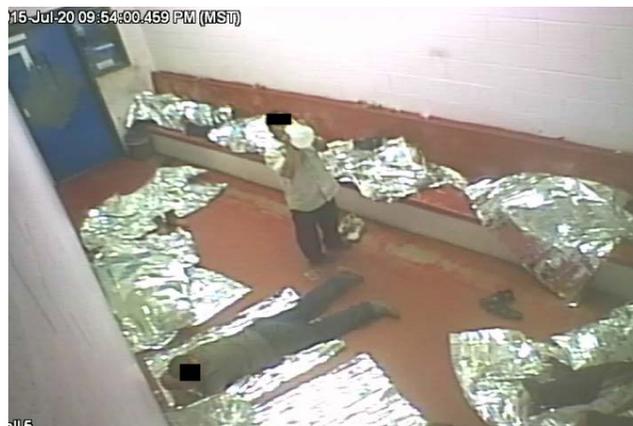
1 (Ex. 130; *see also* Exs. 125, 129, 130, 133, 141.)

18 81. This testimony is confirmed by surveillance video of the Casa Grande which
19 shows at least a dozen different detainees drinking from the same 1-gallon water jug over
20 the course of 5 days:

2 82. The jug was never replaced or cleaned, despite the cell being swept by
3 maintenances crews on several occasions over the course of the 5 days it was used.

1 regularly and repaired quickly when they are broken. If they wish to continue using water
2 jugs as part of their water delivery system, the regular cleaning and refilling of those jugs
3 should be scheduled and logged. In no case should detainees be expected to share the
4 same cups or drink from the same gallon jug as they present an obvious risk of the spread
5 of contagious disease.

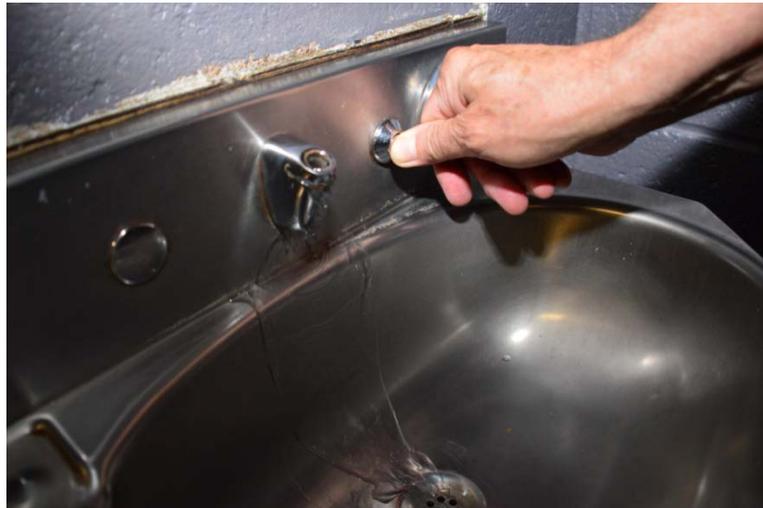
19 (Ex. 31.)

5 83. In hold rooms with “bubblers” to dispense drinking water, these were
6 usually located just above or adjacent to the toilets, often as part of the same metal
7 toilet/sink unit. During each of my inspections of the four stations, I observed numerous
8 bubblers that did not work or had extremely low water pressure. One example of a
9 malfunctioning bubbler is shown in the picture below:

20 84. In general, I believe that the problem with the bubblers is the same as with
21 the toilets—they are subject to overuse as there are not enough of them for the numbers of
22 detainees placed in the holding cells⁶ and they are not regularly inspected and repaired.
